# CH-47 CHINOOK HELICOPTERS: PREVENTING CHAFING DAMAGE ON STRUCTURES WITH DURABLE SEALING AND SURFACE PROTECTION TAPES

## Case Study

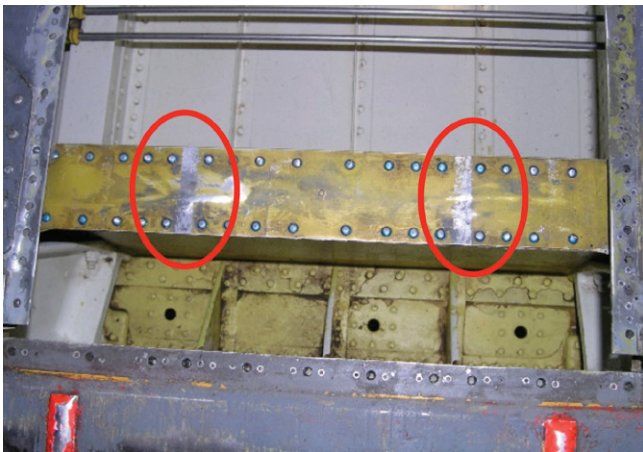
Corrosion and mechanical forces such as continuous vibration can severely damage aircraft structures over time. Consequently, RNLAf operators discovered chafing damage on floor structural beams (Figure 1). The paint was worn away to expose bare metal, setting the conditions for continued wear and corrosion and ultimately requiring repair or replacement of the helicopter structure. They also discovered similar chafing on engine cowlings and various access panels throughout the aircraft (Figures 2–5).

Figure 1: Chafing damage to the floor structure.

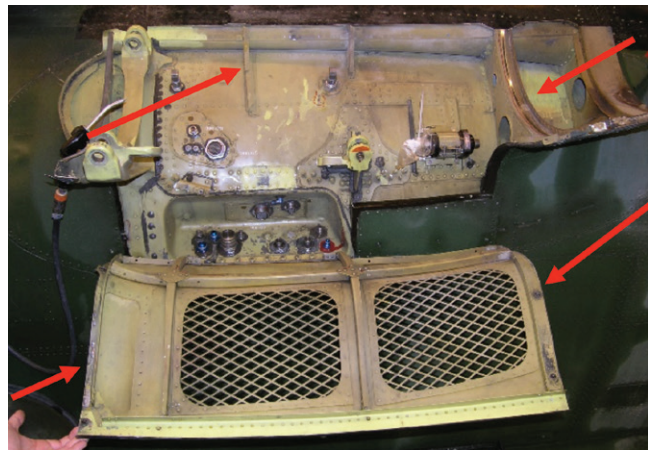
Figure 2: Chafing damage on engine mount fairing and access door.

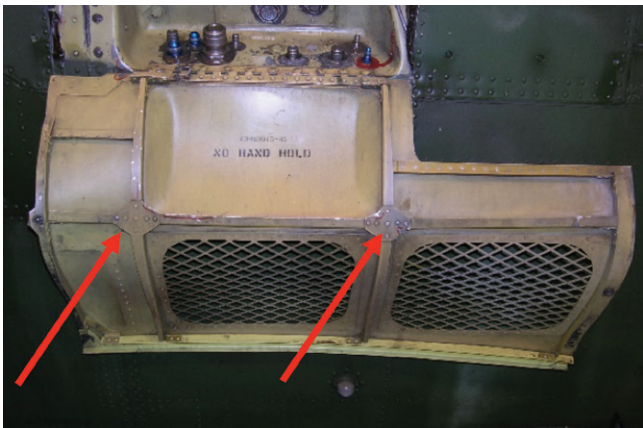
Figure 3: Chafing damage to engine fairing access door.

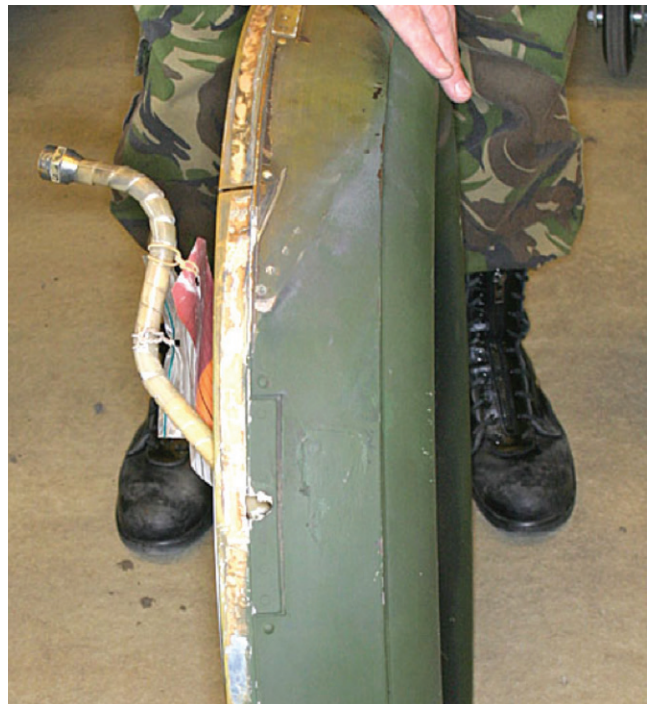
Figure 4: Chafing damage to engine inlet D-ring cowling at mating surface.

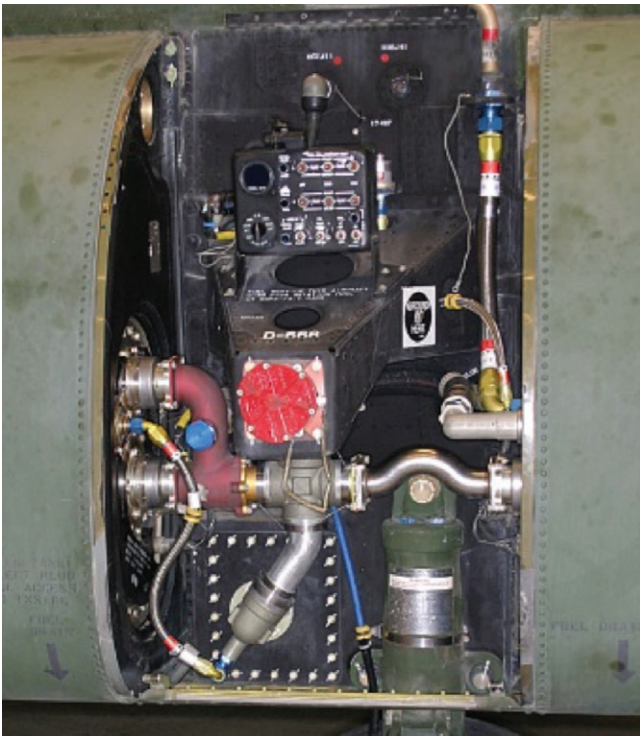
Figure 5: Chafing damage to access panel mating surfaces on fuselage sponson.

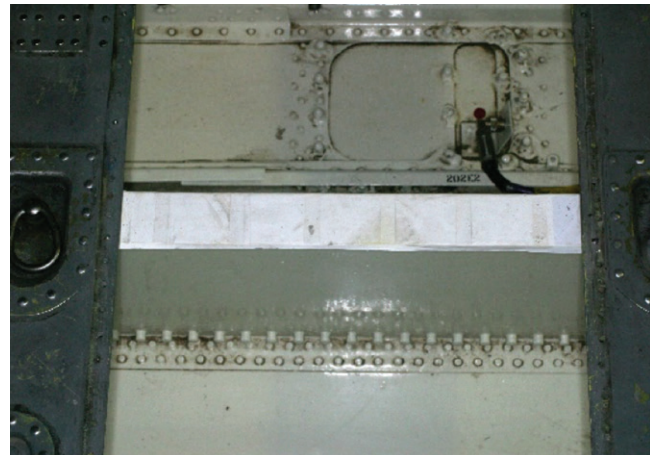
Figure 6: GORE® SKYFLEX® Aerospace Tapes, 700 Series installed on floor beam.

Gore engineers worked closely with the RNLAf to install GORE® SKYFLEX® Aerospace Tapes, 110 and 700 Series to the panels and structure of a CH-47 helicopter. The structure was cleaned prior to installation, and Gore's 700 Series tape was applied to the floor beams (Figure 6). Gore's 110 Series tape was also applied to floor panel mating surfaces along the panel perimeter. In addition, they installed the 700 Series tape on the engine mounts and cowlings at key panel contact surfaces to protect chafing caused by vibration, as well as panels and mounting surfaces.

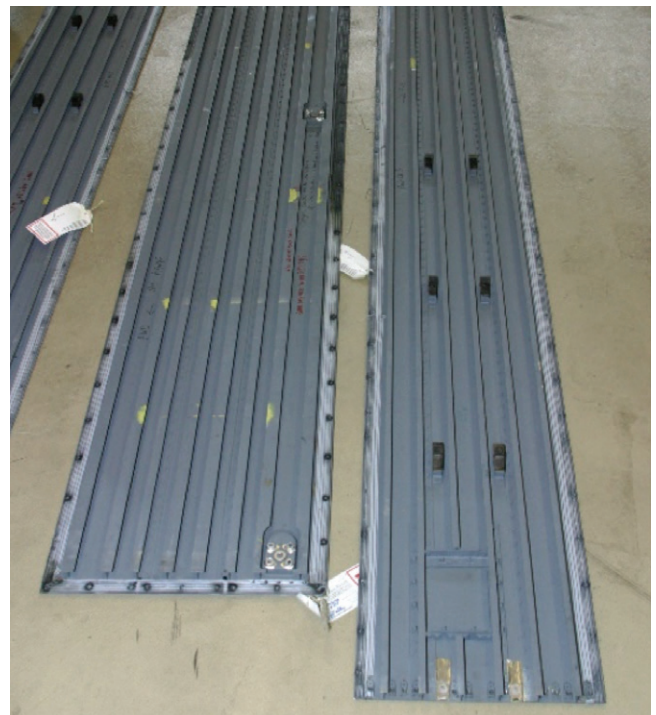
Next, they conducted thorough flight testing through normal operational use, and results showed that Gore's ePTFE (expanded polytetrafluoroethylene) tapes effectively sealed and protected the underlying helicopter structure. Figure 7 shows that Gore's 110 Series installed on floor panels remained serviceable after 400 flight hours.

Figure 7: GORE® SKYFLEX® Aerospace Tapes, 110 Series installed on floor panels.

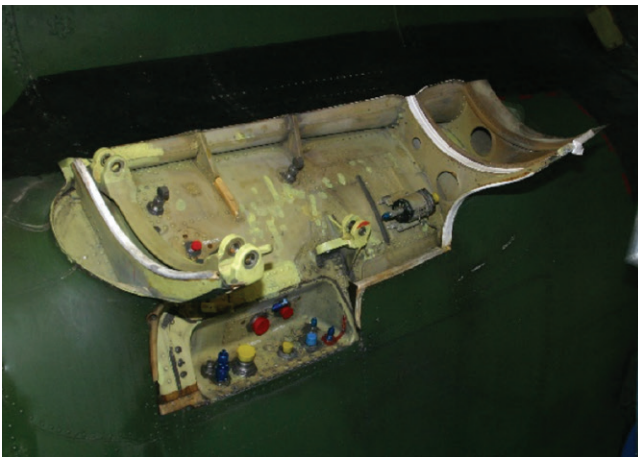
Similarly, results showed that Gore’s 700 Series installed on an engine mount structure, although discolored, remained intact and functional (Figure 8). The 700 Series installed on engine access door and cowling contact areas also remained intact and effective after 400 flight hours (Figures 9 and 10).

Figure 8: GORE® SKYFLEX® Aerospace Tapes, 700 Series installed on engine mount structure.

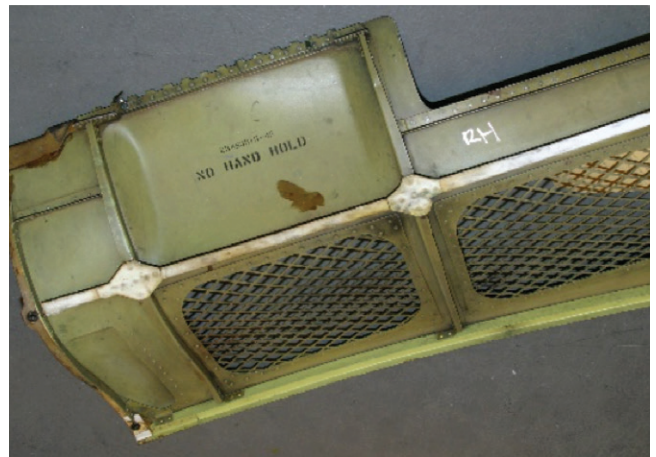
Figure 9: GORE® SKYFLEX® Aerospace Tapes, 700 Series installed on engine access door.

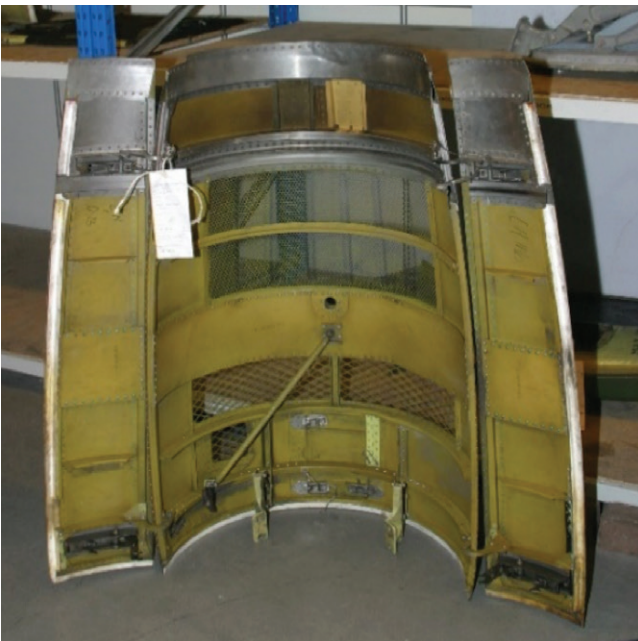
Figure 10: GORE® SKYFLEX® Aerospace Tapes, 700 Series installed on engine cowling contact areas.

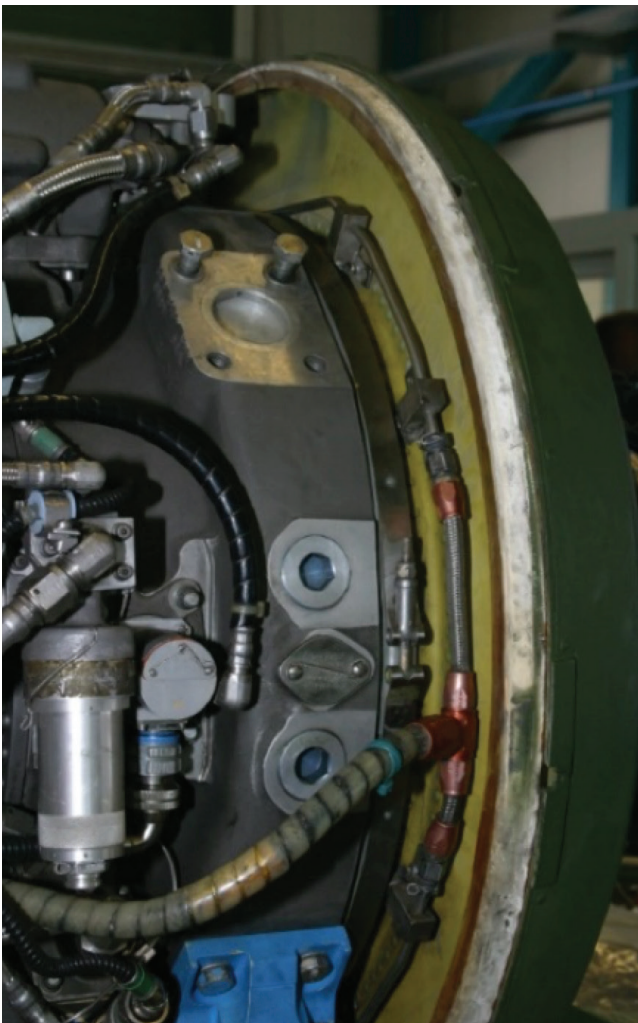
Figure 11 shows that the 700 Series installed on an engine inlet D-ring cowling and contact areas effectively absorbed friction and wear from panel contact. Furthermore, results showed that the 700 Series installed on the upper engine inlet screen assembly was still serviceable after preventing cowling wear (Figure 12).

Figure 11: GORE® SKYFLEX® Aerospace Tapes, 700 Series installed on engine inlet D-ring cowling.

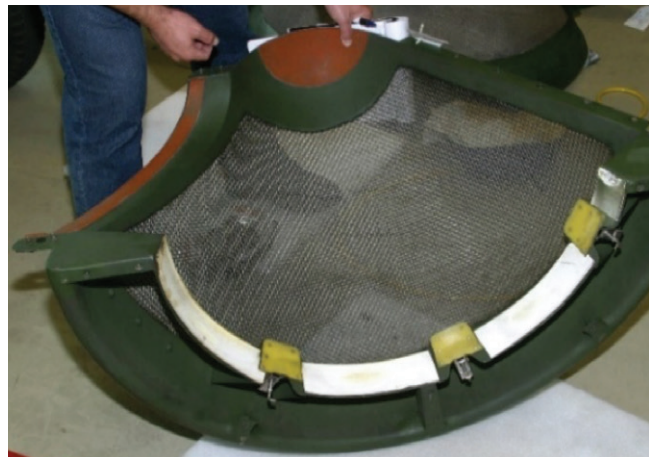
Figure 12: GORE® SKYFLEX® Aerospace Tapes, 700 Series installed on upper engine inlet screen assembly.

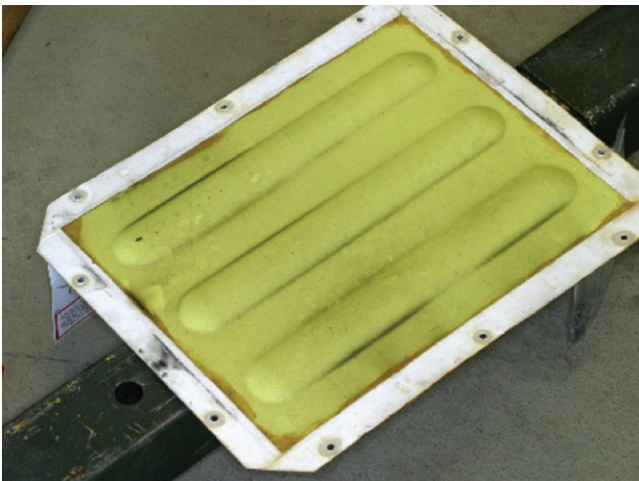
In addition, test results showed that Gore's 700 Series installed on access panels and panel mating surfaces of the helicopter provided durable protection against chafing. The 700 Series installed on the aft pylon canted deck cover (Figure 13), and transmission access panel (Figure 14) prevented chafing and remained functional after 400 flight hours.

Figure 13: GORE® SKYFLEX® Aerospace Tapes, 700 Series installed on aft pylon canted deck cover.

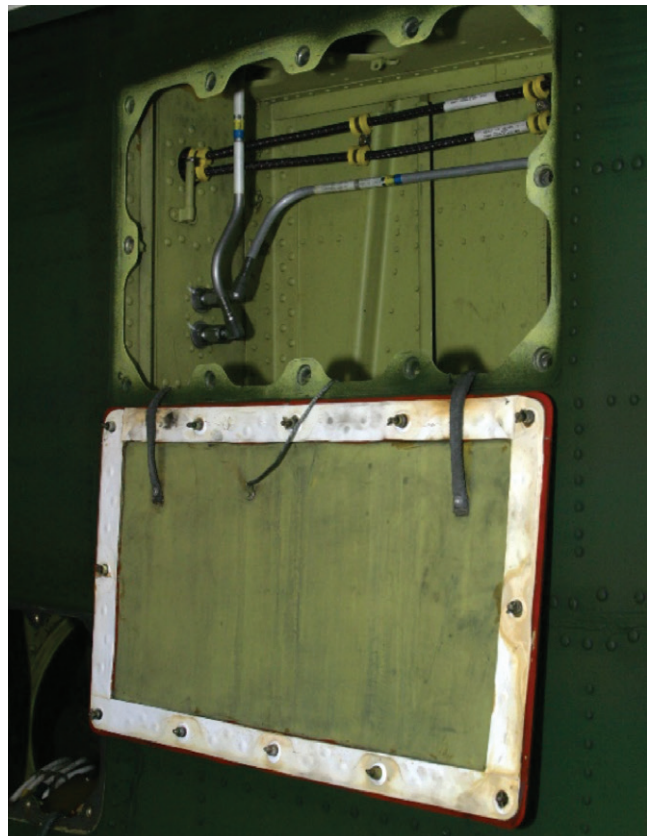
Figure 14: GORE® SKYFLEX® Aerospace Tapes, 700 Series installed on aft pylon transmission access panel.

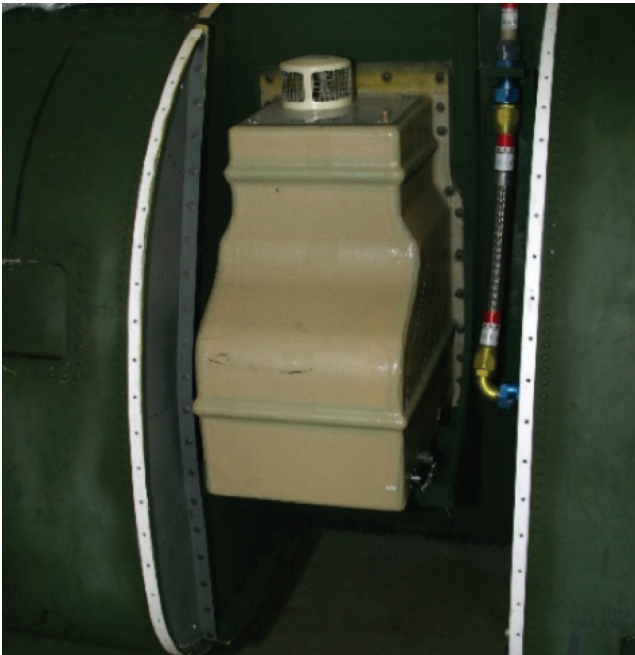
Likewise, results showed that the 700 Series successfully protected sponson access panel mating surfaces against chafing with no damage to the panels (Figure 15). Finally, Figure 16 shows that the 700 Series installed to the mounting surface for the forward transmission drip pan remained intact after rigorous flight testing with no damage to the panels or structure.

Figure 15: GORE® SKYFLEX® Aerospace Tapes, 700 Series applied to sponson access panel mating surfaces.

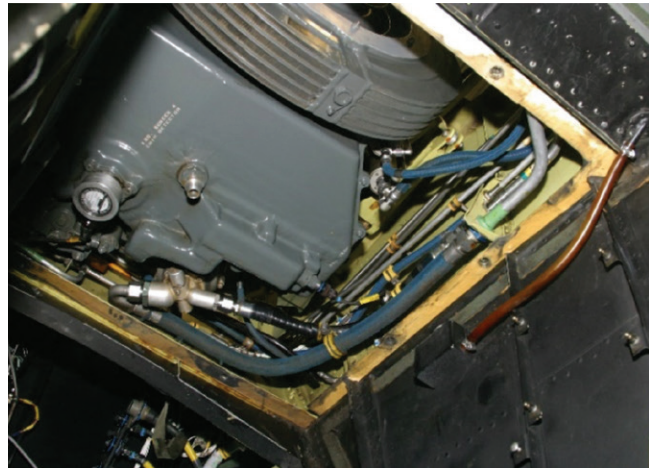
Figure 16: GORE® SKYFLEX® Aerospace Tapes, 700 Series applied to mounting surface for forward transmission drip pan.
